Study of Radiographic Linear Indications and Subsequent Microstructural Features in Gas Tungsten Arc Welds of Inconel 718

J.L. Walley

A.C. Nunes

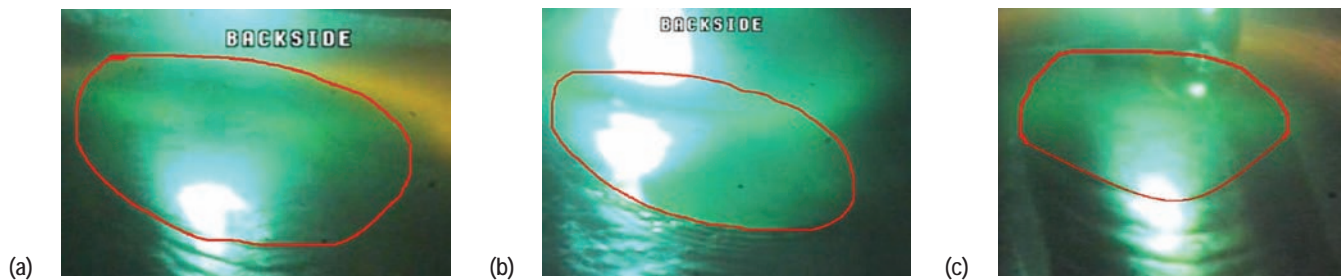
Figure 4. Differently shaped molten puddles: (a) round (JT-03), (b) oval (JT-02), and (c) tear-drop (JT-04). The label BACKSIDE denotes that weld direction is upward, that the observer is looking behind the weld puddle.

During the nominal weld settings (JT-02), the welders observed an oval-shaped weld puddle (fig. 4(b)) and postweld inspections showed an appropriate amount of reinforcement.

The tear-drop weld puddle (fig. 4(c)) was created using the fastest travel speed (JT-04). It had excessive crown reinforcement and little root reinforcement, in contrast to the round weld puddle. Also, mismatch caused by inadequate clamping forces from the fixture was seen near the end of several panels, most noticeable on panel JT-05. Reduced puddle size at the faster travel speeds made it easier to identify joint mismatch.

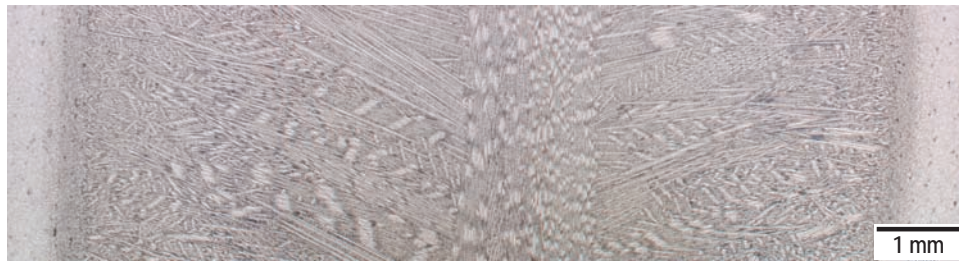
Figure 9. Crown macro of JT-03_1 region. In the center is a long grain with a substructure of dendrites. The weld direction is from top to bottom.

The slowest travel speed (JT-03) was cut into macros at two locations—one where the linear indications parallel to the joint were easily defined as a dark and light line pair (JT-03_1) and the second in a location where there was only one grey indication (JT-03_2). The macros from both locations showed that longitudinal columnar dendrite structures were formed parallel to the joint, which was easy to see in the crown macros in figures 9 and 10. The transverse cross sections show that at the JT-03_1 location (fig. 11) columnar dendrites are lined up through the depth of the weld, with a consistent boundary and thickness through the depth of the weld. In contrast, the transverse macro from JT-03_2 showed that the boundaries between parallel columnar dendrites and the rest of the weld nugget are not parallel to each other and the region's thickness is also not consistent through the depth of the weld as seen in figure 12.

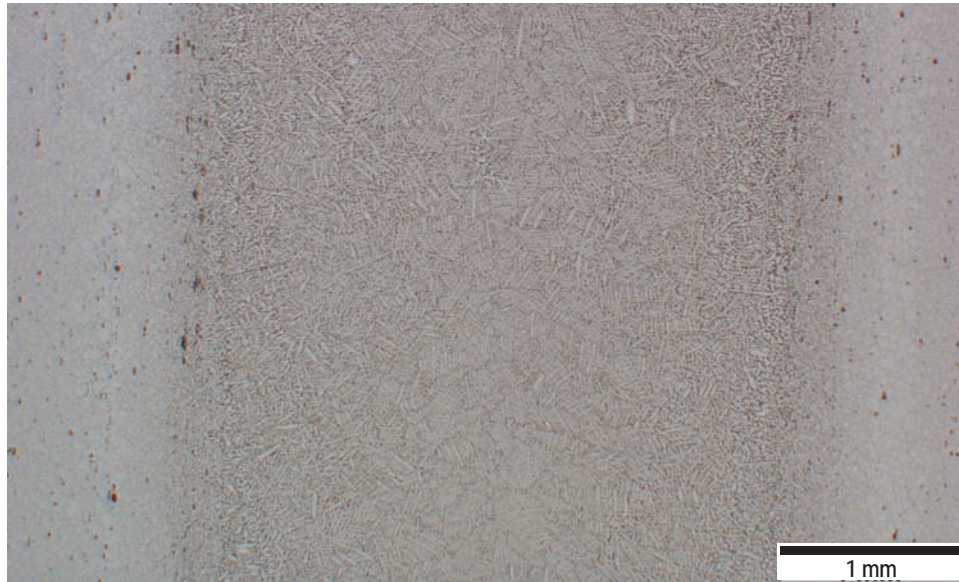
Figure 15. Crown macro of JT-04. Notice there is no relative orientation preference for the dendrite formations. Notice that weld direction is indiscernible for this joint.

The crown macro for the tear-drop weld speed (JT-04) shows a random equiaxed dendrite orientation (fig. 15). The higher magnification (fig. 16) verifies this random configuration. The relatively high solidification velocity of the fastest weld speed apparently does not allow time for columnar formation since the transformation kinetics of the Inconel 718 structure is slow.

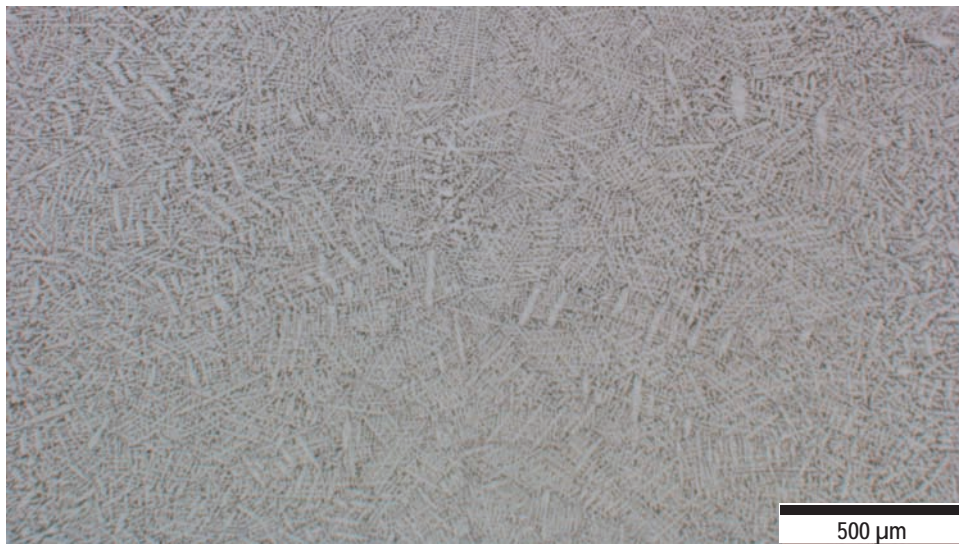
Figure 16. Crown macro enlarged of JT-04. Notice there is no relative orientation preference for the dendrite formations.

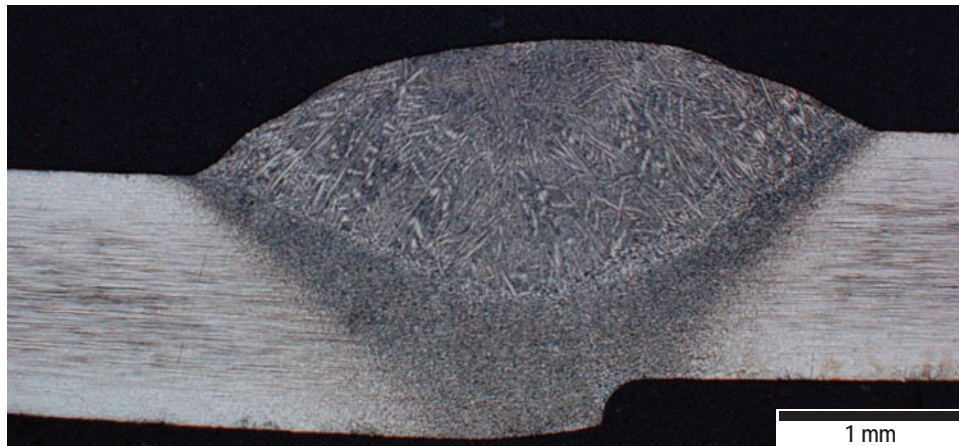
Figure 18. Transverse macro of JT-05. Notice the visible mismatch on the root side.

By varying the clamping pressure on the panels during welding, the welders were able to produce a joint with significant mismatch, near the end of the panel. From the radiographic image (fig. 17), it can be seen that this mismatch created an indication in the form of an ~ 0.01 -in light and dark region on either side of a boundary running approximately along the middle of the weld. The macro image of figure 18 explains the indication. The crown is flat, but there is a step at the weld root, such that the thickness penetrated by the x-ray beam is significantly different on opposing sides of the step.

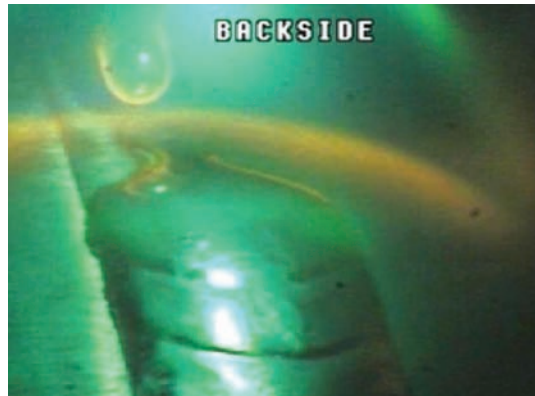
Figure 19. Segment of weld JT-08. The bead has been displaced toward the right until it has been moved almost off the joint (see transverse section fig. 21), which can be seen extending from the left edge of the bead. At this point, the joint is only being partially consumed by the weld bead.

The lack of fusion weld was created by cross sliding the weld puddle until the joint was seen just at the edge of the crown reinforcement (fig. 19). The radiograph showed a blurry dark line at the position where the cross slide moved the bead back to the middle of the joint (fig. 20) but there was no visible indication for the remaining length of the missed joint. The macro shows that there was almost complete lack of fusion for the length of the joint (fig. 21). Penetrant testing was conducted on JT-08 and produced visible porosity indications on the root side of the weld along the length of the joint.

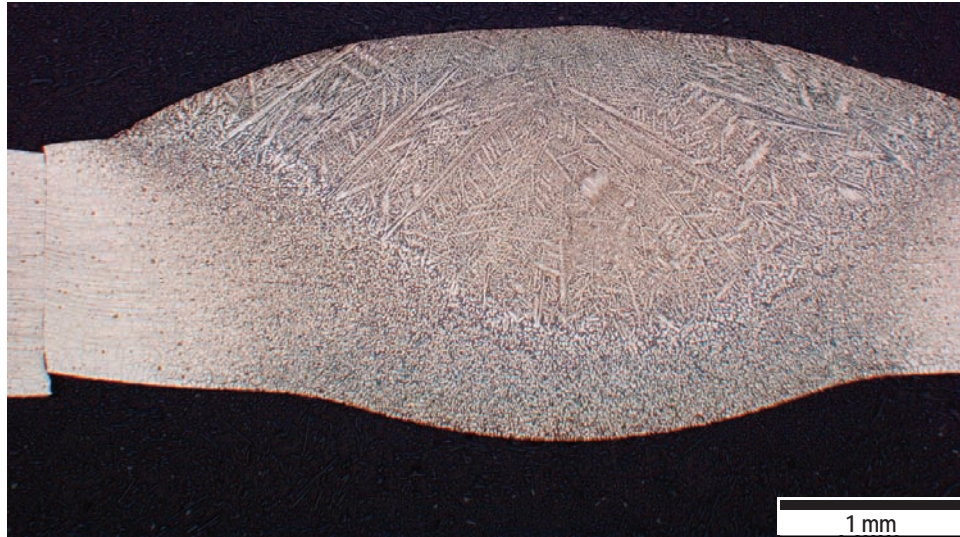
Figure 21. Transverse macro of weld JT-08, where a missed joint can be seen on the left side of the image. The crown is on the top.
